MEASUREMENT OF FLYING QUALITIES OF A DEHAVILLAND

MOSQUITO F-8 AIRPLANE (AAF NO. 43-334960)

I - LATERAL AND DIRECTIONAL STABILITY

AND CONTROL CHARACTERISTICS

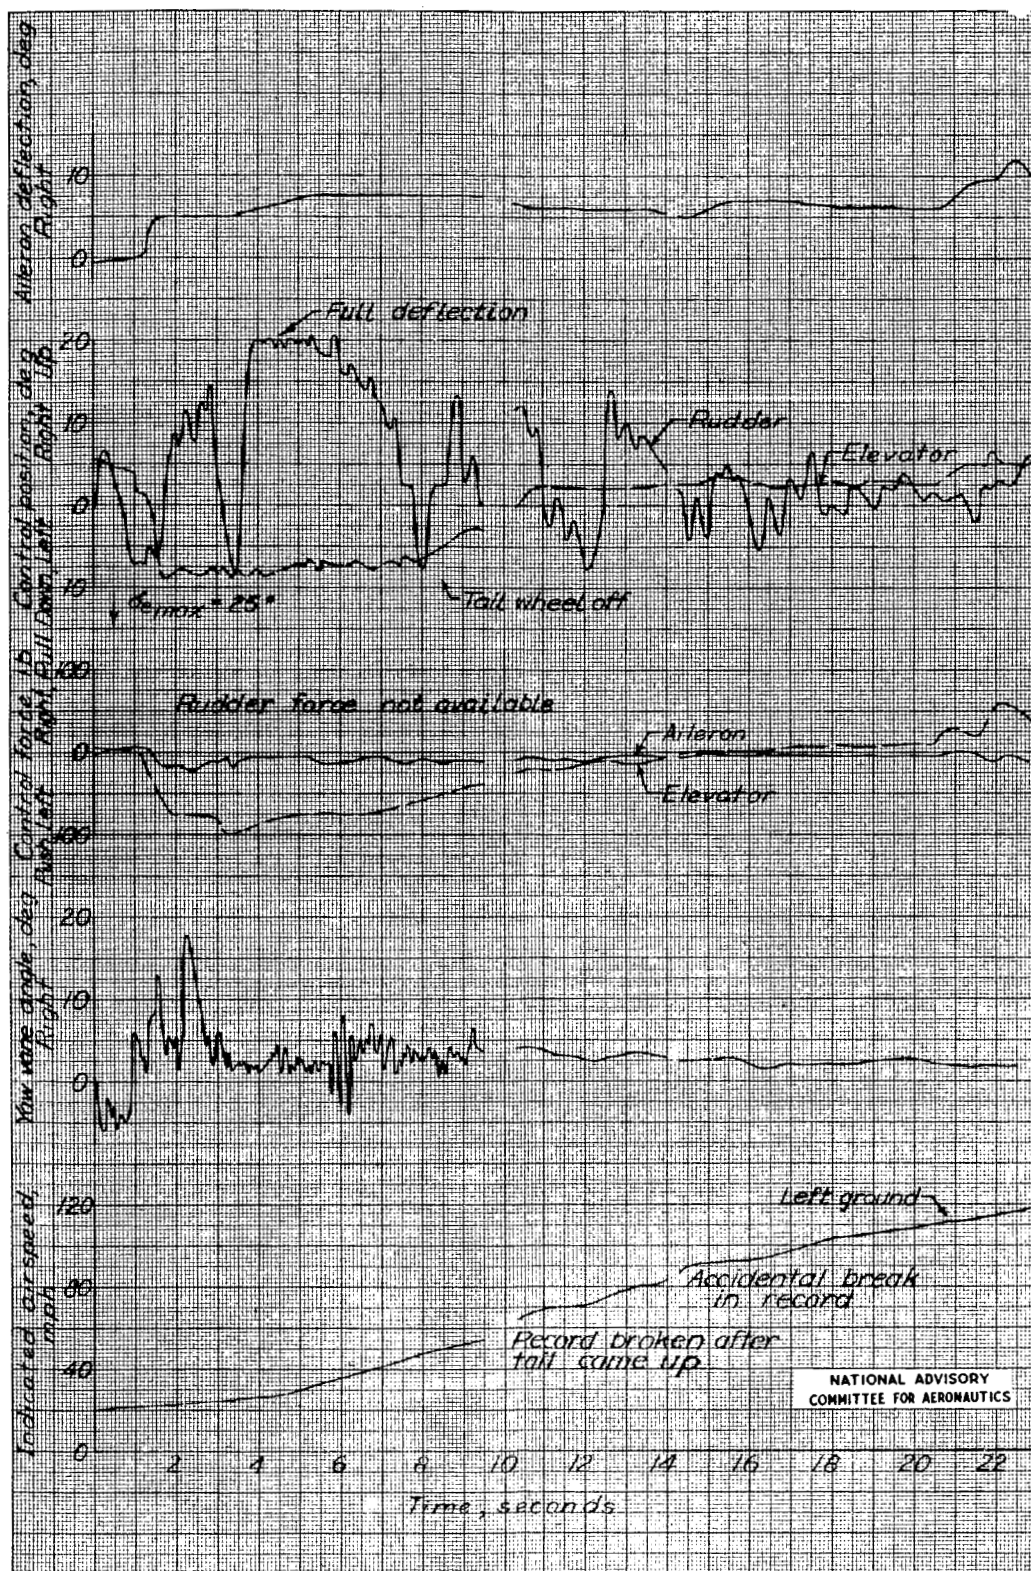
Figure 18. - Time history of a take-off using 10 pounds boost at 3000 rpm, shutters open, flaps up, center of gravity at 35 percent M.A.C., DeHavilland Mosquito F-8 airplane.

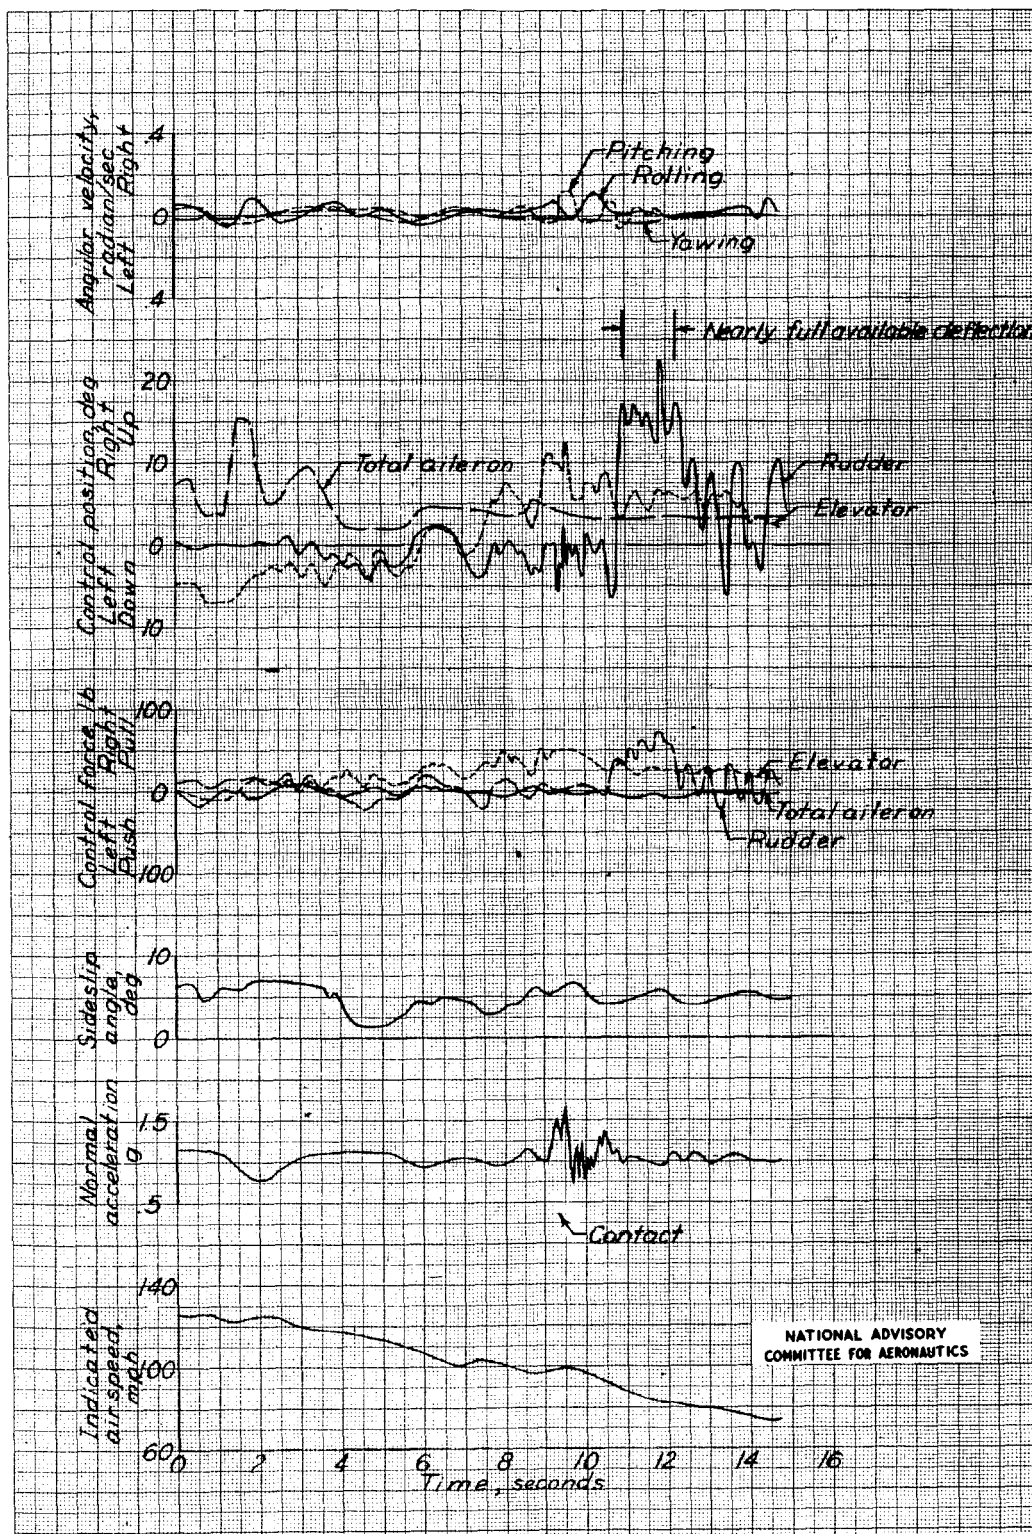
Figure 19. - Time history of a landing with the center of gravity at 35 percent M.A.C., flaps down, landing gear down, engines idling, De-Havilland Mosquito F-8 airplane.

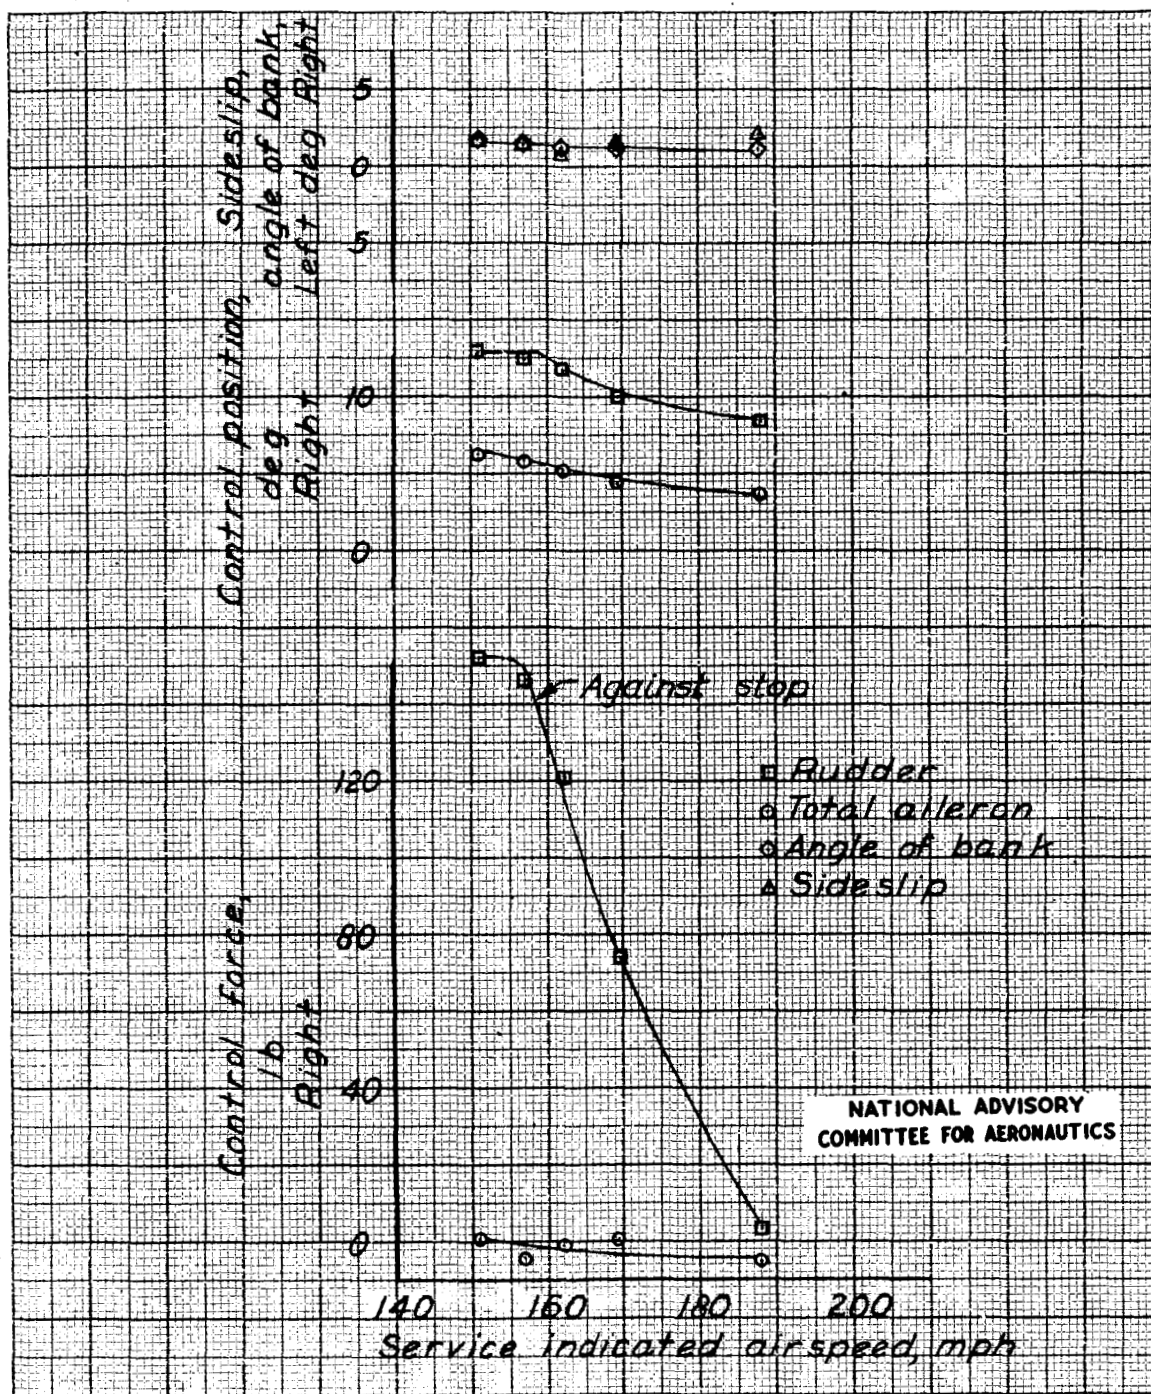
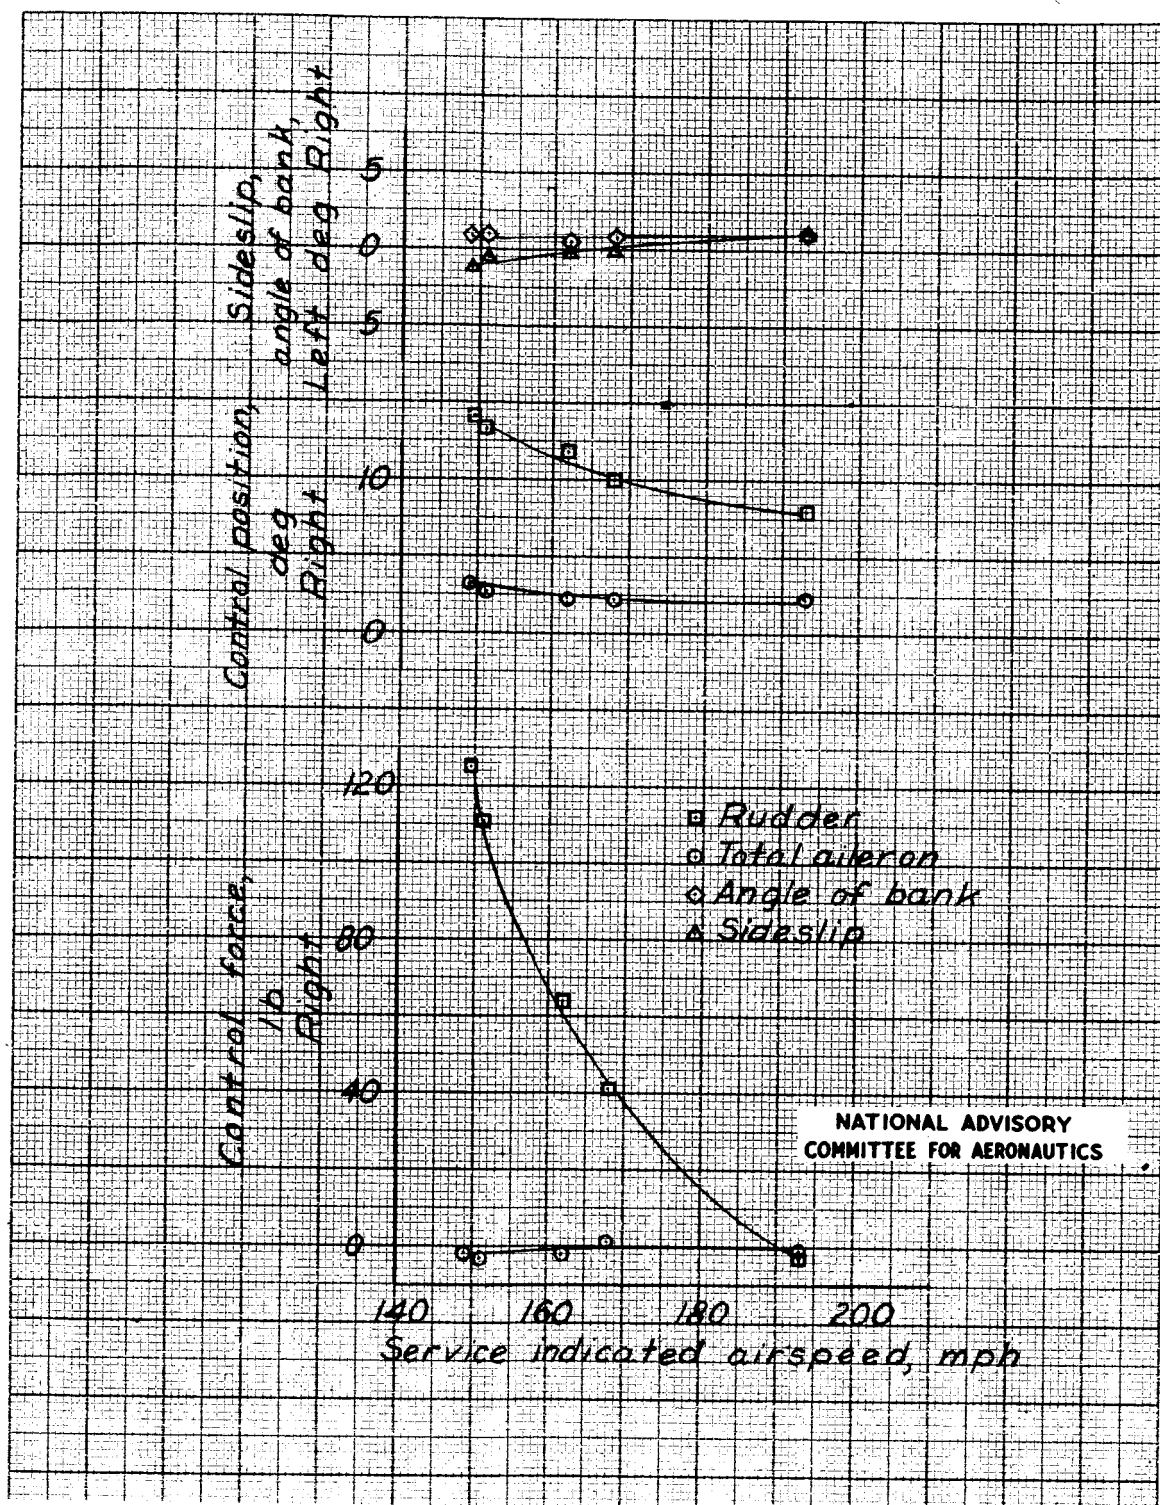
a. Left propellers windmilling with the governor set at 2650 rpm, rudder tab 18.8° full left from rudder.

Figure 20. - Directional trim characteristics for single engine operation in the rated power clean condition with left shutter closed and right shutter open, DeHavilland Mosquito F-8 airplane.

b. Left propeller feathered, rudder tab 13.5 degrees left from rudder.

Figure 20 presents the directional trim characteristics for single-engine operation in the rated-power, clean condition in straight flight with the wings level. Data were obtained with the left propeller windmilling with the governor set at 2650 rpm and also with the left propeller feathered. Figure 20 shows that full tab deflection, left from the rudder, was required to trim the rudder force to zero at 190 miles per hour with the left propeller windmilling, and about  $1/3$  less, with the left propeller feathered. The rudder control was sufficient to maintain straight flight in either case with the wings level at 150 miles per hour. By holding a slight degree of bank it was possible to maintain

directional control to the stall in the clean condition. During single-engine flight with the wings level the rudder force increased rapidly with decreasing speed from 0 at 190 miles per hour to 120 pounds with the left propeller feathered, or 135 pounds with the left propeller windmilling at 150 miles per hour. Due to the deflection of the spring and the flexibility of the rest of the rudder system the available rudder deflection was reduced 10 per 10 pounds of control force. Over half of the available no-load deflection was lost at 150 miles per hour in the case illustrated in figure 20. Placing stops only on the rudder itself would remedy this situation. The rudder trimming tab was powerful enough to trim out the rudder-control forces with the wings level at 190 miles per hour with one propeller windmilling or at 170 miles per hour with one propeller feathered. No records were obtained of banked single-engine flight, but less rudder deflection would be required so that the minimum speed at which full tab deflection would produce zero rudder-control force would be reduced. The aileron-control forces were negligible and could easily have been trimmed out.

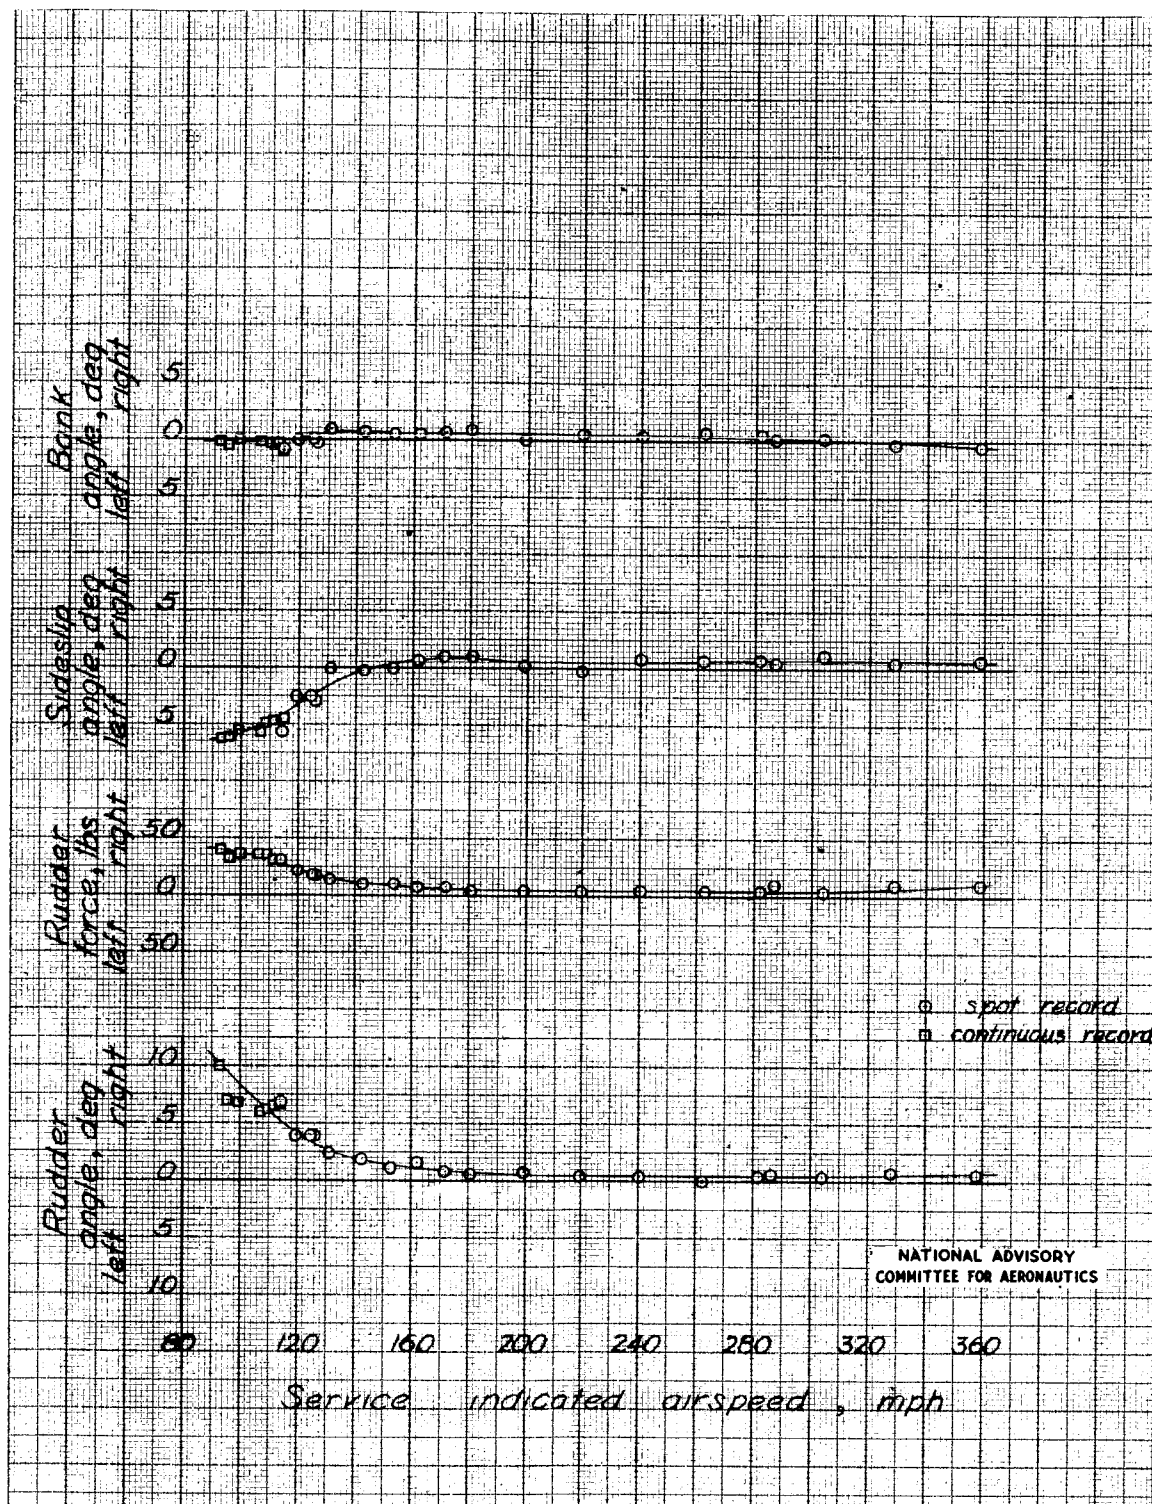
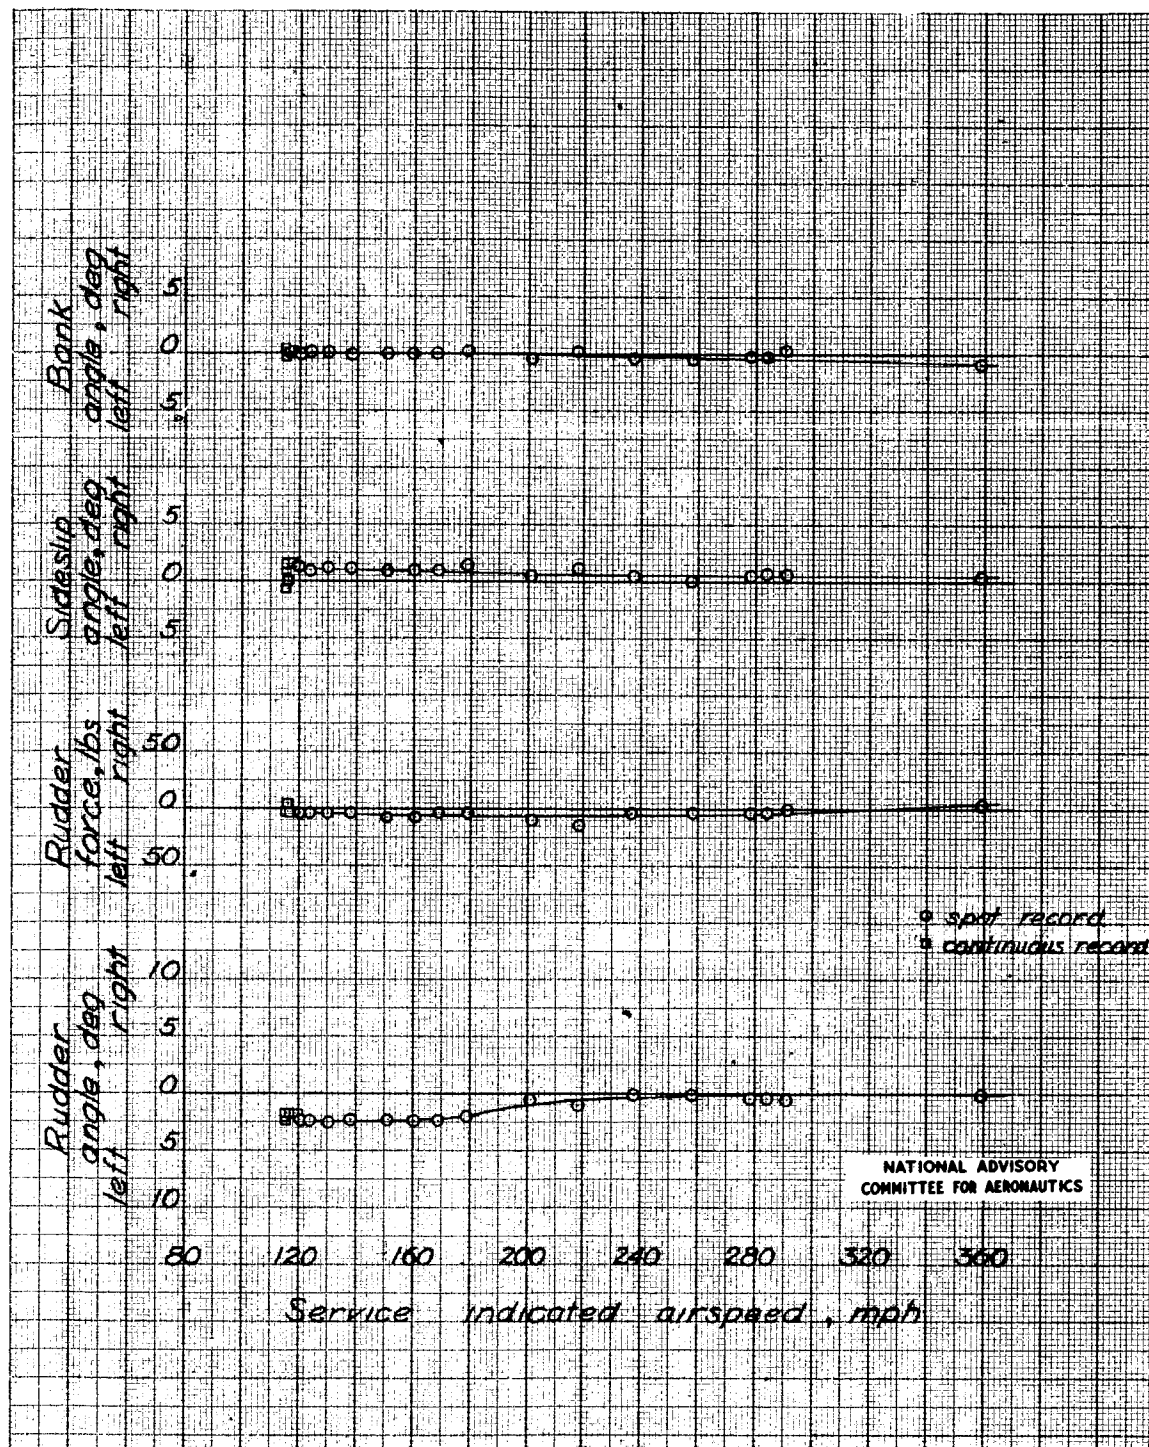
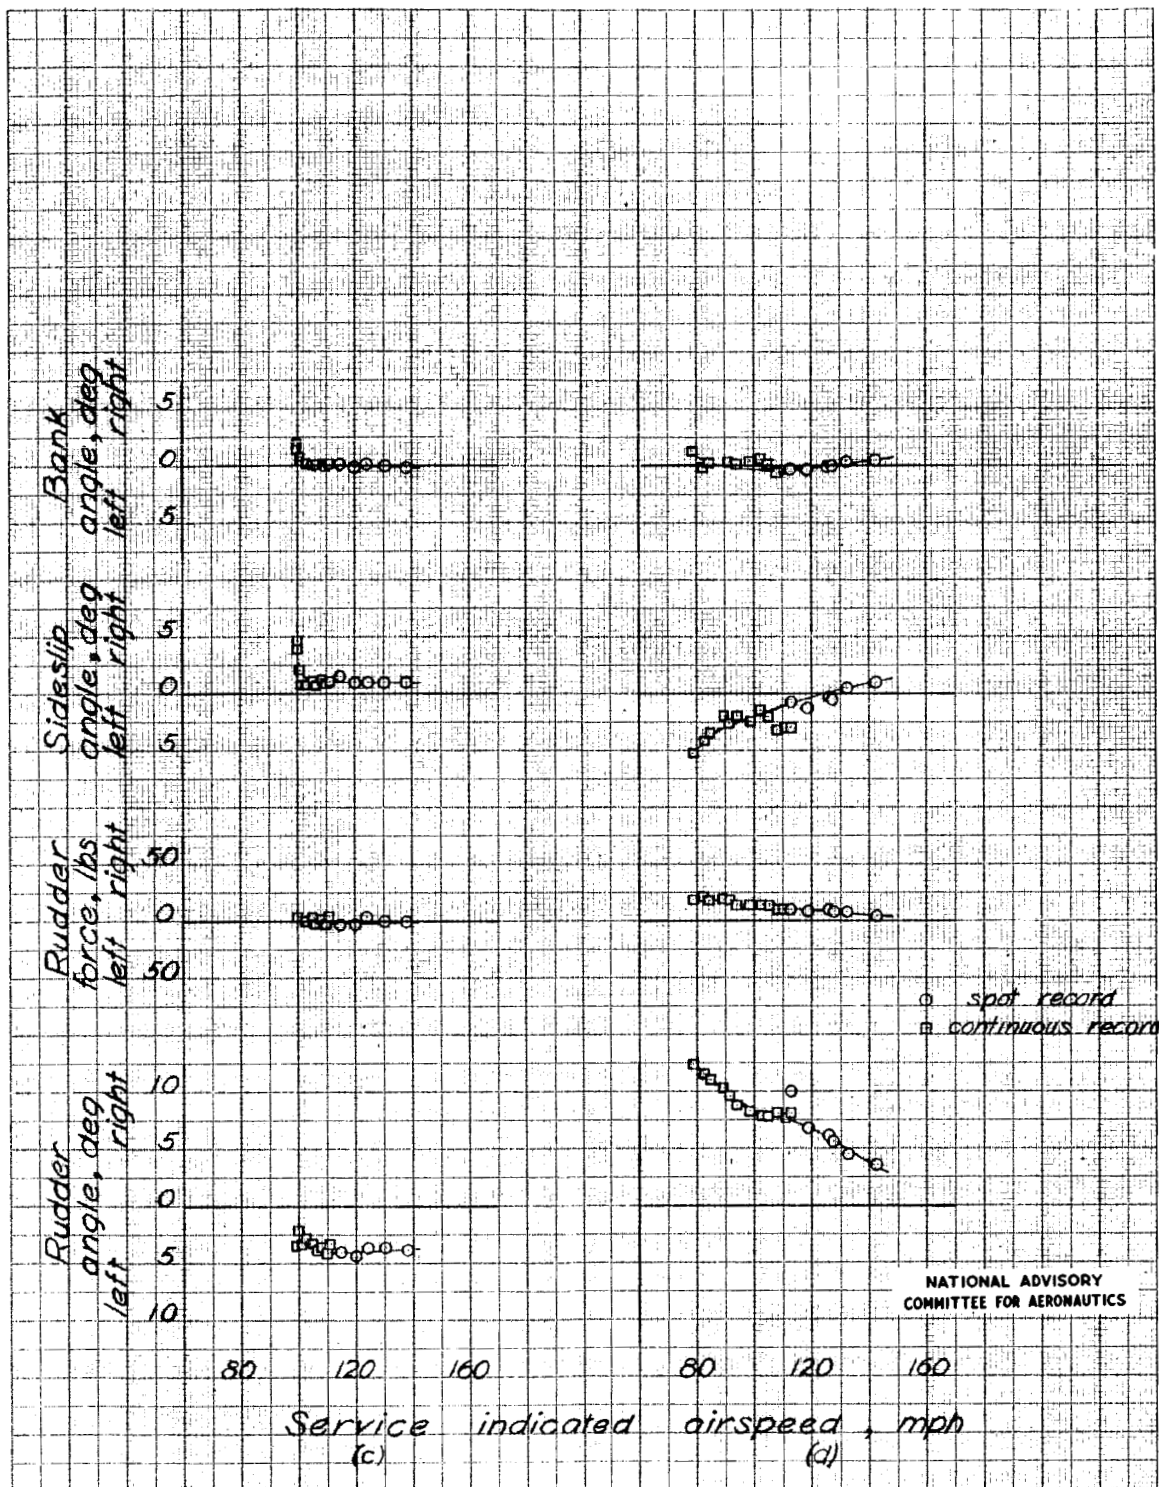
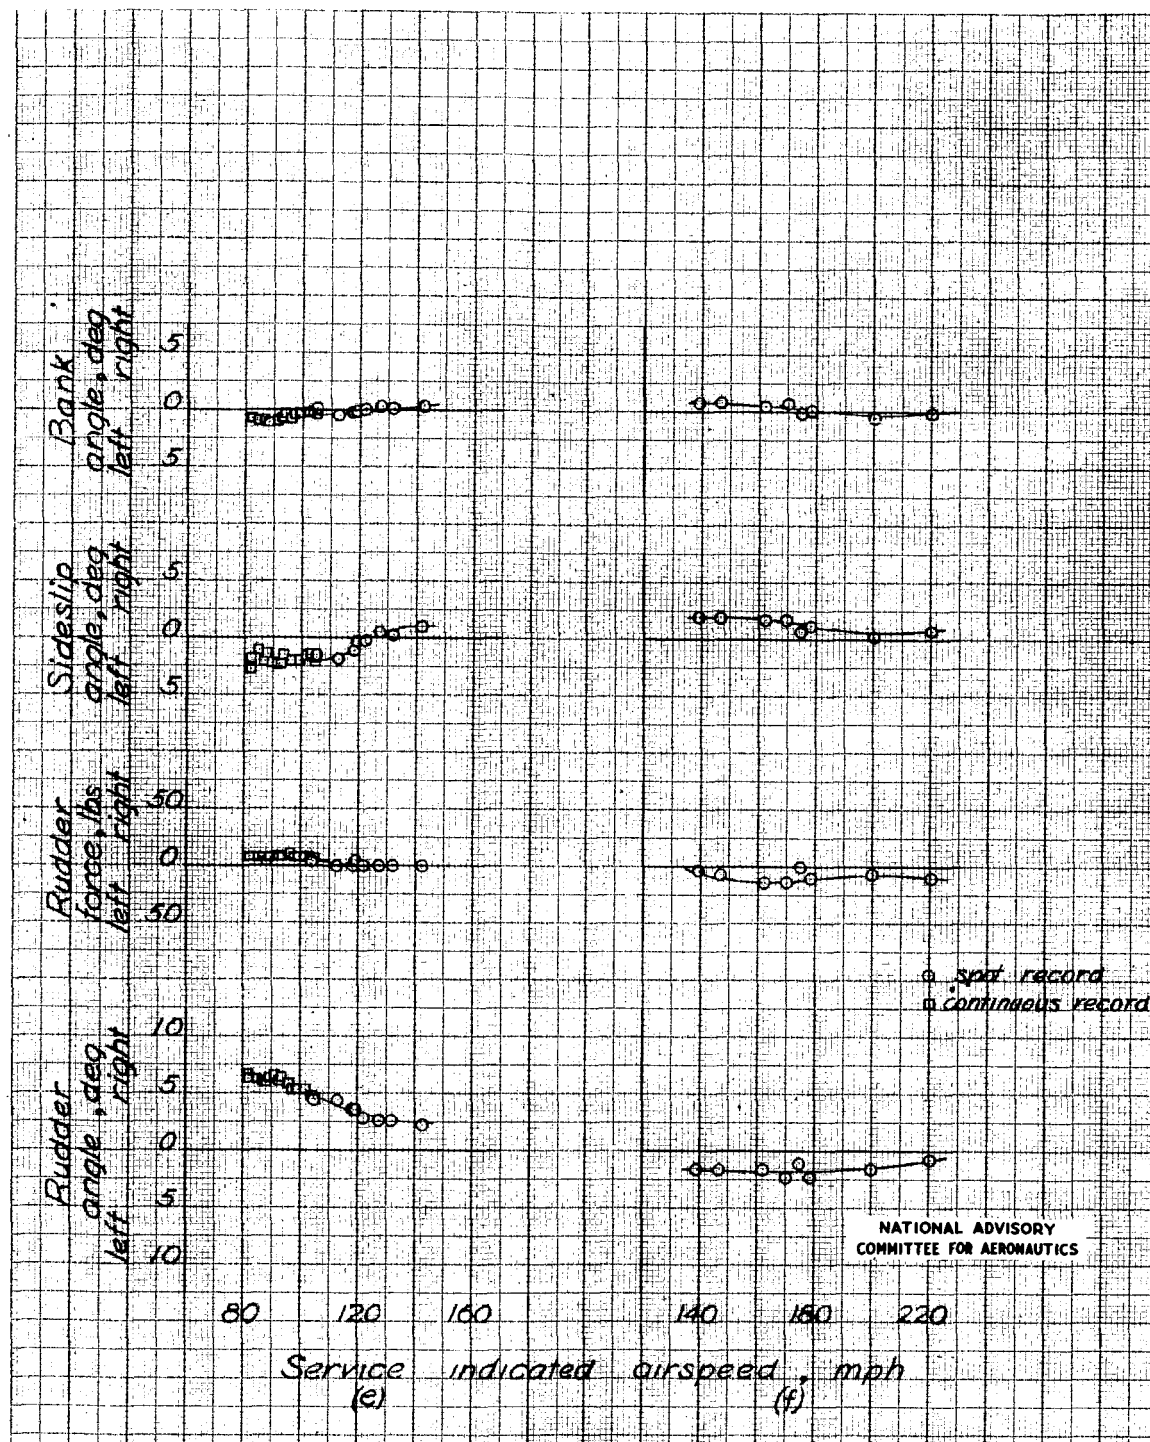
a. Rated power, clean condition, shutters closed (2650 rpm, 7 pounds boost), center of gravity at 38.3 percent M.A.C., rudder tab at 0 degrees.

Figure 21. - Directional trim characteristics in various flight conditions, DeHavilland Mosquito F-8 airplane.

b. Engines idling, clean condition, shutters closed, center of gravity at 38.3 percent M.A.C., rudder tab 3.2 degrees right.

- c. Flaps and landing gear down, engines idling, shutters open, center of gravity at 36.8 percent M.A.C., rudder tab 6.5 degrees left.
- d. Flaps and landing gear down rated power (2650 rpm. 7 pounds boost), shutters open, center of gravity at 36.8 percent M.A.C., rudder tab 5.6 degrees left.

e. Flaps and landing gear down, approach power (2650 rpm, 0 boost), center of gravity at 36.8 percent M.A.C., rudder tab 4.2 degrees left.

f. Clean condition cruising power, (2650 rpm, 4 pounds boost) shutters open, center of gravity at 38.3 percent M.A.C., rudder tab at 0 degrees.

From trim at maximum level-flight speed with power on or trim at the same speed with the engines idling the rudder-control force changed only 10 pounds in going to 360 miles per hour, the maximum speed attained in these tests. This is shown in the directional-trim curves of figure 21, which indicate small variation of rudder force with speed in all conditions.

The power of the rudder trimming tab to trim the rudder forces to zero at any speed in any of the test conditions is also indicated by figure 21. The variation of aileron-control force with speed was small except in high-speed dives as shown in figure 22 and was easily trimmed out. The power of the trimming tabs during single-engine operation has been discussed in 3-B, 3.

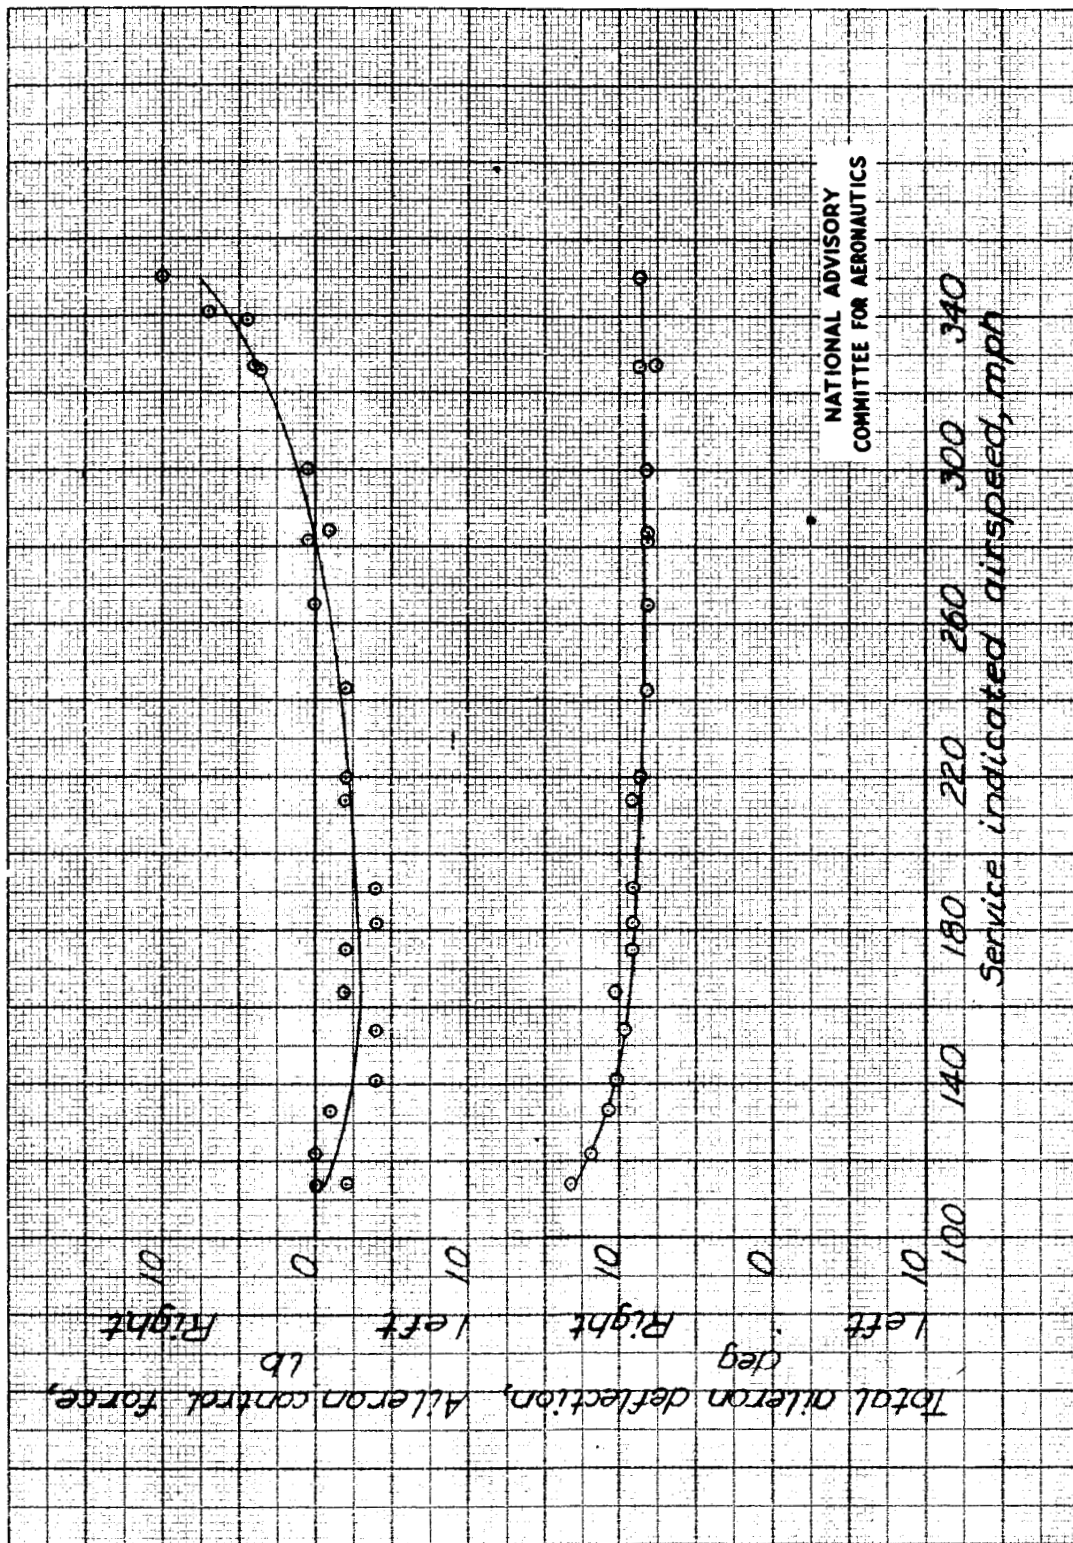
Figure 22. - Variation of aileron deflection and control force for trim with indicated airspeed, in the rated-power, clean condition, De-Havilland Mosquito F-8 airplane.

g. The variation with airspeed of aileron deflection and control force required to hold the wings level in the rated-power, clean condition is shown in figure 22. The amount of aileron deflection would vary with any variation of lateral loading, but fuel was always used symmetrically so that little variation of lateral loading occurred in the tests. The large amount of aileron deflection required for trim indicated that an effective twist was present in the wing structure. An effective twist of approximately  $1^\circ$  on each tip would be required to account for the amount of aileron deflection that was used for trim. A tendency for the force to increase rapidly to the right at high speeds would become objectionable before the maximum diving speed, 450 miles per hour, was reached.

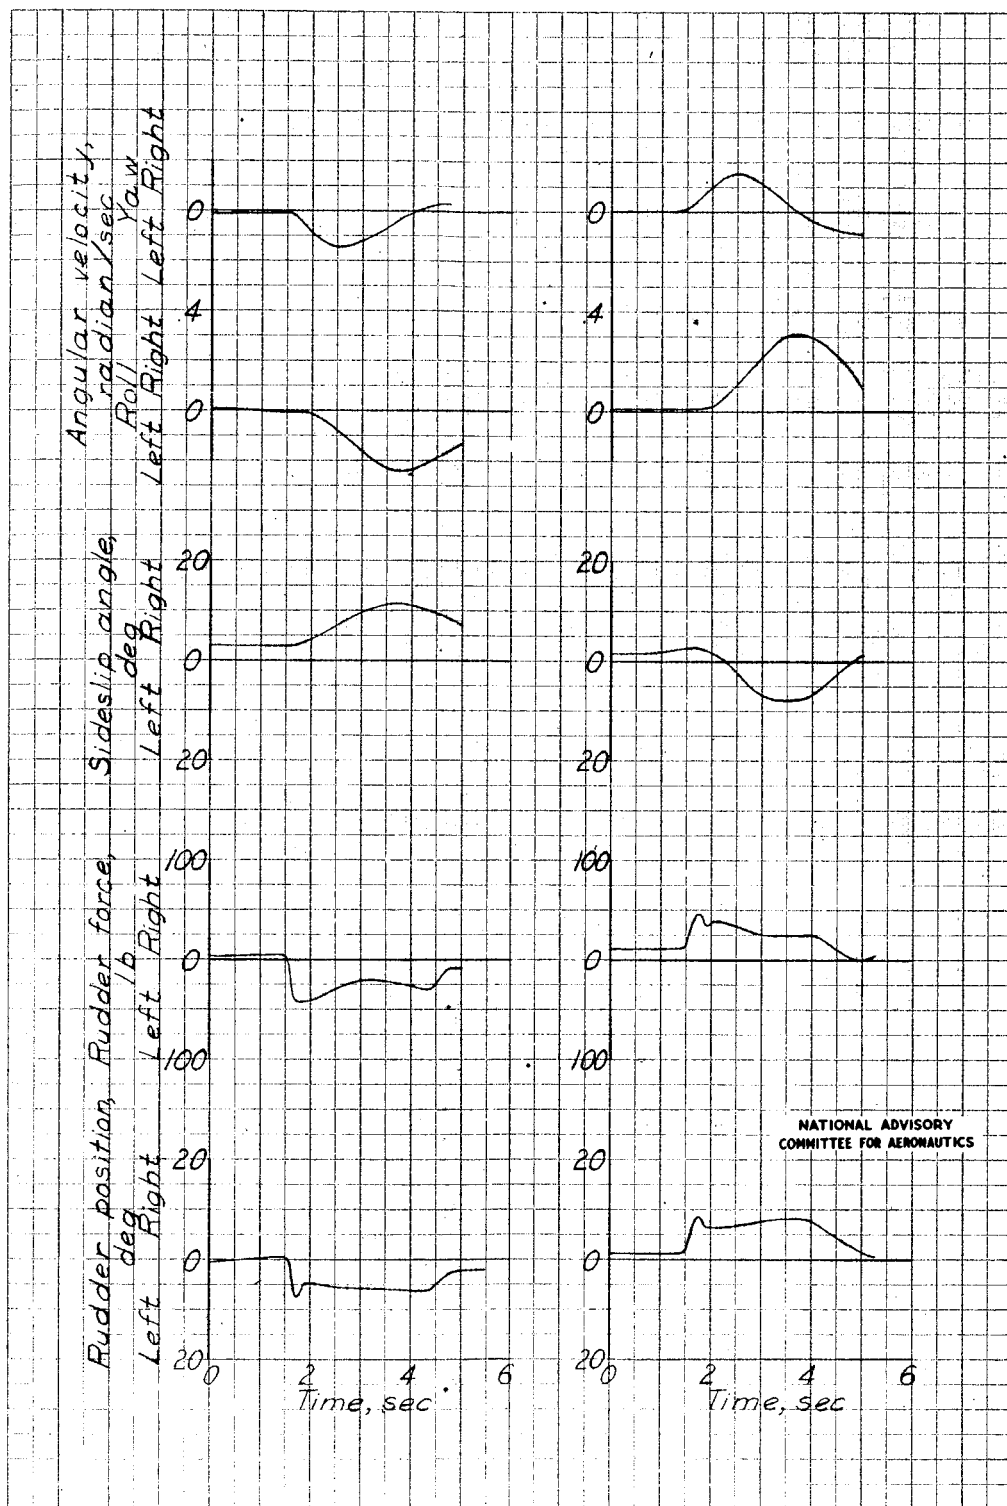
Figure 23. - Time histories of rudder kicks at 200 miles per hour in the clean condition with power for level flight in which deflection was held to maximum sideslip, DeHavilland Mosquito F-8 airplane.

Rudder kicks were made at 140 and 200 miles per hour in the clean condition with power for level flight to determine the amount of rolling due to yawing. In these maneuvers the rudder was abruptly deflected and held fixed as well as possible at the deflected position and the aileron and elevator were held fixed throughout the maneuver. Time histories of rudder kicks at 200 miles per hour are shown in figure 23. The maximum change in sideslip angle, rolling and yawing velocity, and rudder force are presented as a function of rudder deflection in figure 24. Because of the very light rudder forces the rolling velocity produced with a given rudder force was large but was not considered objectionable by the pilot.

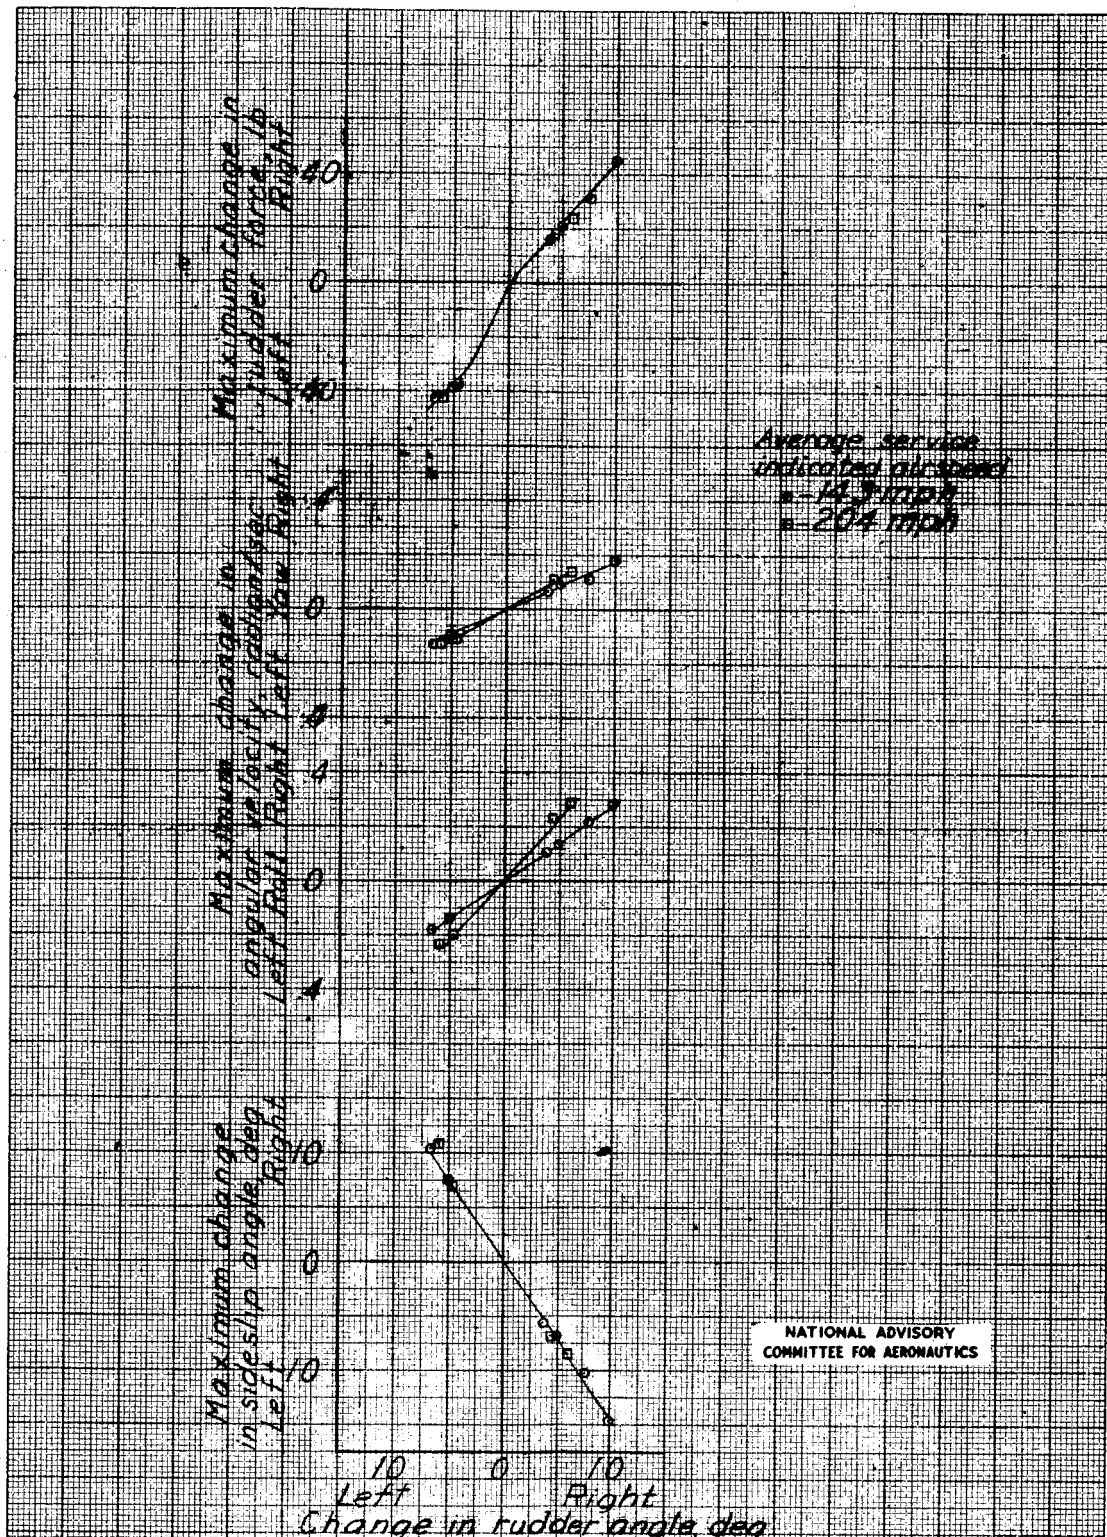
Figure 24. - Variation of maximum change in rudder force, rolling and yawing velocity, and sideslip angle with rudder position in rudder kicks at 140 and 200 miles per hour in the clean condition with power for level flight, DeHavilland Mosquito F-8 airplane.

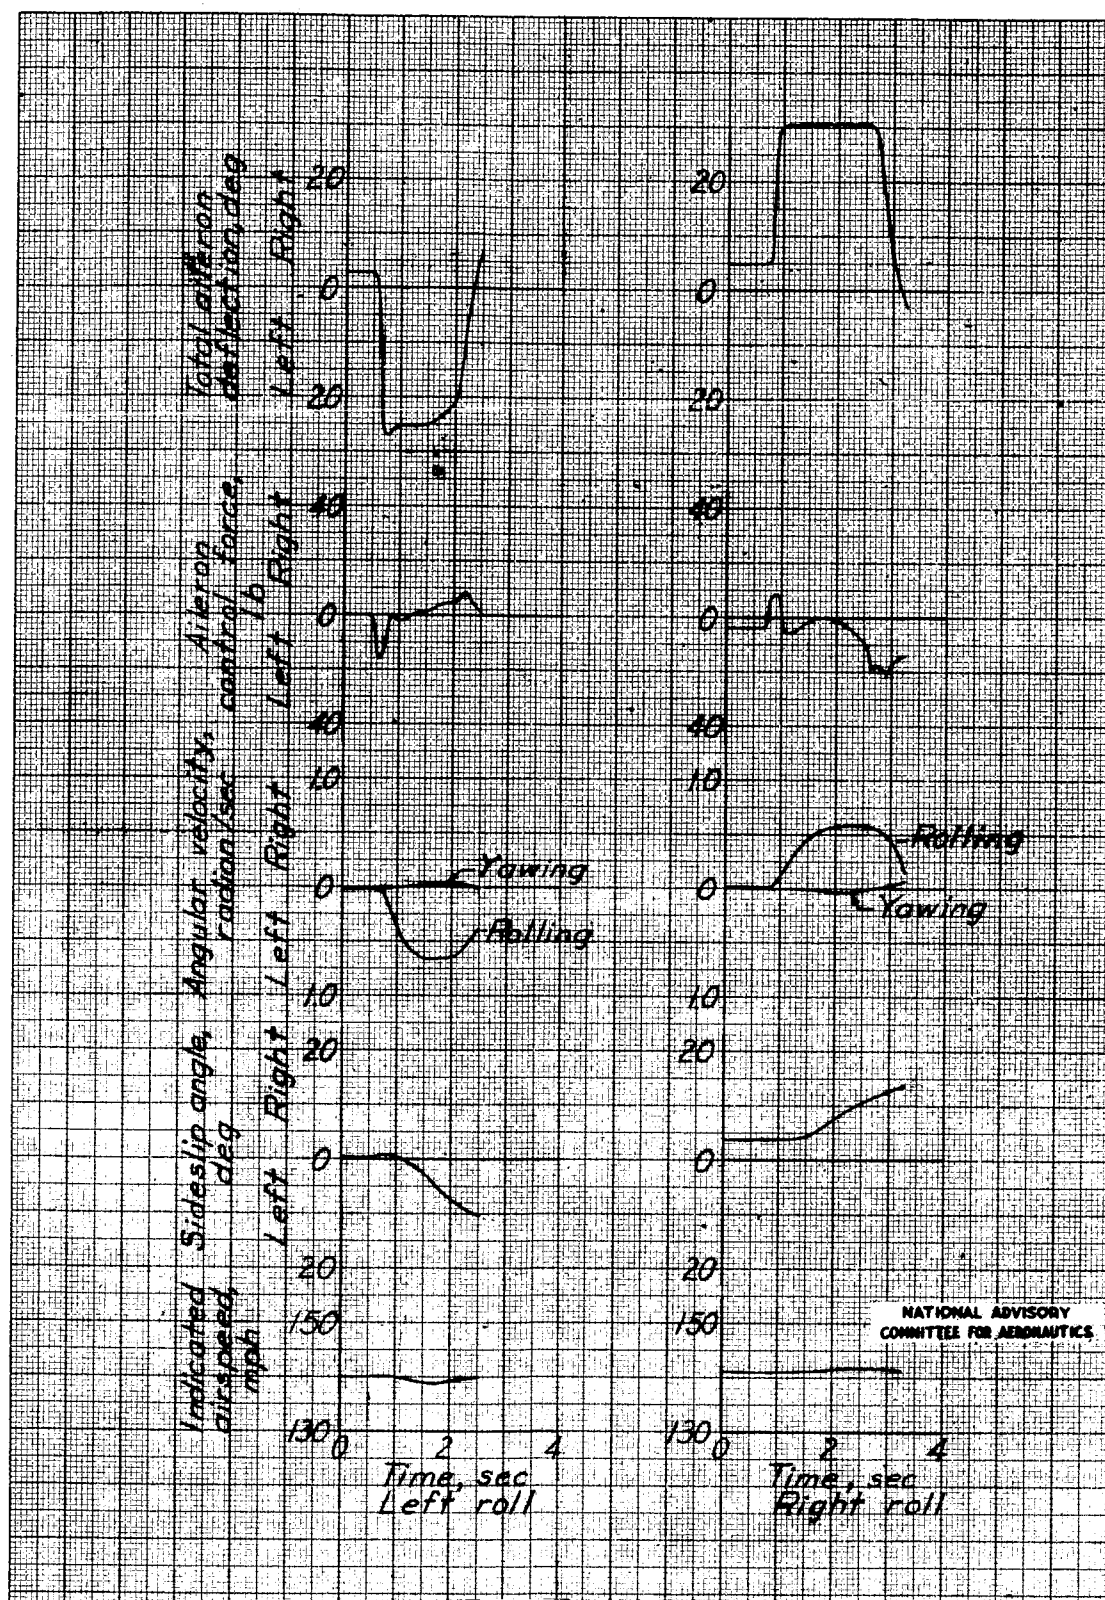
Figure 25. Time histories of rudder-fixed, abrupt aileron rolls at 140 miles per hour, indicated, in the clean condition using power for level flight shutters open, DeHavilland Mosquito F-3 airplane.

Time histories of typical left and right rolls at 140 miles per hour with level-flight power in the clean condition are presented in figure 25. The values of rolling effectiveness obtained and wheel forces required are plotted as a function aileron deflection in figures 26, 27, and 28. No information was available on permissible aileron deflections at high speed so aileron deflection was arbitrarily limited above 200 miles per hour.

figures 25 through 28 indicate that on this particular Mosquito aileron overbalance occurred in rolls in all conditions below 200 miles per hour over a considerable range of aileron deflections. It has been stated previously that the ailerons tended to shake when fully deflected and that an example of aileron shaking is presented in figure 10(c).
